ROAD SAFETY AUDIT

Bedford Street and Hartwell Avenue

Town of Lexington

November 2011

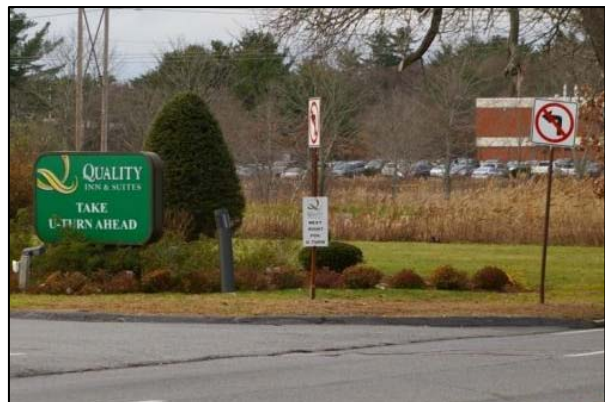
In an effort to reduce the incidence of angle and rear-end collisions throughout the Bedford Street corridor, left-turn restrictions have been put in place at many of the driveways and other intersecting roadways. However, the RSA team noted that left-turn restrictions are often inconsistent, with restrictions placed at some locations and not

General sign clutter and confusing U-turn signage

others and some with time restrictions and some without, which has significantly added to sign clutter, motorist confusion, and the need for constant enforcement by the Lexington Police Department.

Several RSA members suggested the possibility of installing a median along Bedford Street to physically prohibit all left-turns; however, a place to reverse direction would be needed if a median were to be installed. More generally, the corridor is surfeited with guide signs, some of which are faded, contributing to visual white noise that causes many motorists to miss important visual cues, especially when confronted with high traffic volumes and speed conditions.

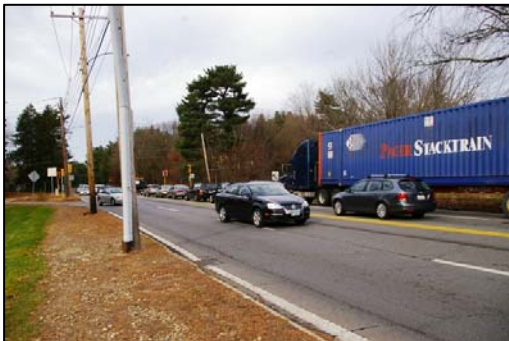
High volumes and speeds are an issue throughout the corridor

Due to the numerous office and commercial uses, as well as Hanscom AFB and MIT Lincoln Laboratory, along the Bedford Street and Hartwell Avenue corridors, traffic volumes in the area generally intensify significantly during the weekday commuter peak periods, resulting in traffic congestion throughout the area. RSA team members noted that three of the office parks along Hartwell Avenue typically hire police details during the afternoon commuter peak period to facilitate vehicles exiting the parking areas onto Hartwell Avenue. Team members also noted that when security levels are raised at Hanscom AFB, vehicle queues from intensive gate-checks spill into the corridor and can extend beyond Bedford Street. In fact, security checks on a normal day at Hanscom AFB can result in traffic congestion and queuing throughout the corridor. RSA team members noted that the Town has tried to work with Hanscom AFB to implement flexible work hours for employees; however, AFB has indicated that attempts to allow flexible work hours were unsuccessful to meet the needs of their operations.

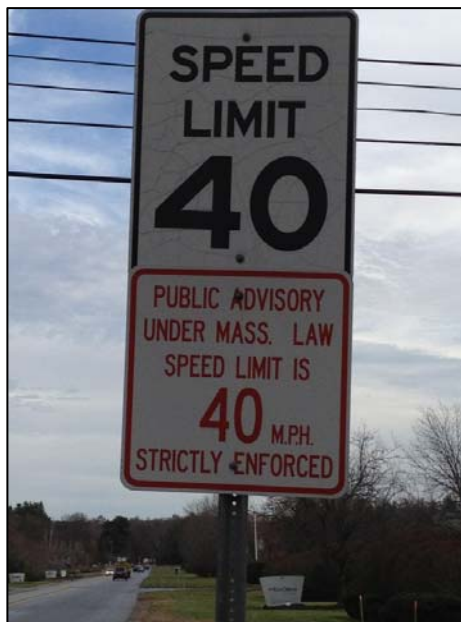
Non-standard advisory speed sign

During the field visit, the RSA team also noted several speed signs along Hartwell Avenue that appeared to be non-standard, including one with white lettering on a red background indicating “Reduce Speed” and an advisory speed sign indicating “Public Advisory Under Mass. Law Speed Limit is 40 M.P.H. Strictly Enforced”. An RSA team member commented that these signs should be evaluated for conformance to Manual on Uniform Traffic Control (MUTCD) standards.

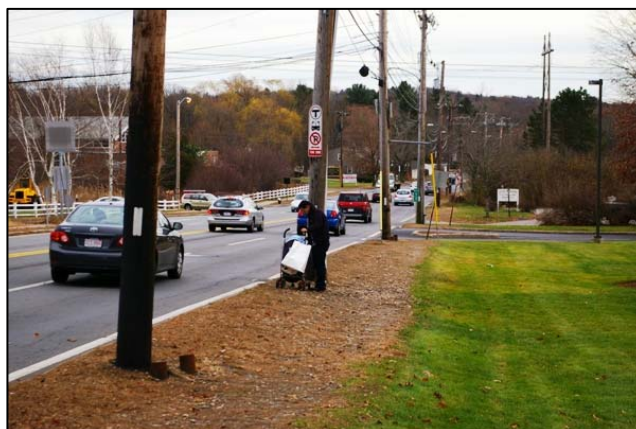
At several locations, RSA team members noted that MBTA bus stops have not been placed to maximize efficient loading/unloading and rider safety. In spite of obvious desire lines worn into the roadside grass, much of Hartwell Avenue and Bedford Street does not have sidewalks and/or pedestrian connections to bus stops. Where sidewalks are present, they appear to be non-ADA compliant. Sidewalks are generally provided along the north side of Bedford Street only; during the RSA, team members noted a pedestrian desire line worn in the grass in some locations along the south side of Bedford Street. No sidewalks are provided on either side of Hartwell Avenue with the exception of one segment of sidewalk located on the west side of the roadway between Bedford Street and Westview Street. No crosswalks are provided across Bedford Street and just one crosswalk (signalized) provides safe access across Hartwell Avenue at the Minuteman Bikeway.

Poor access to bus stops, no shelters, and no benches.

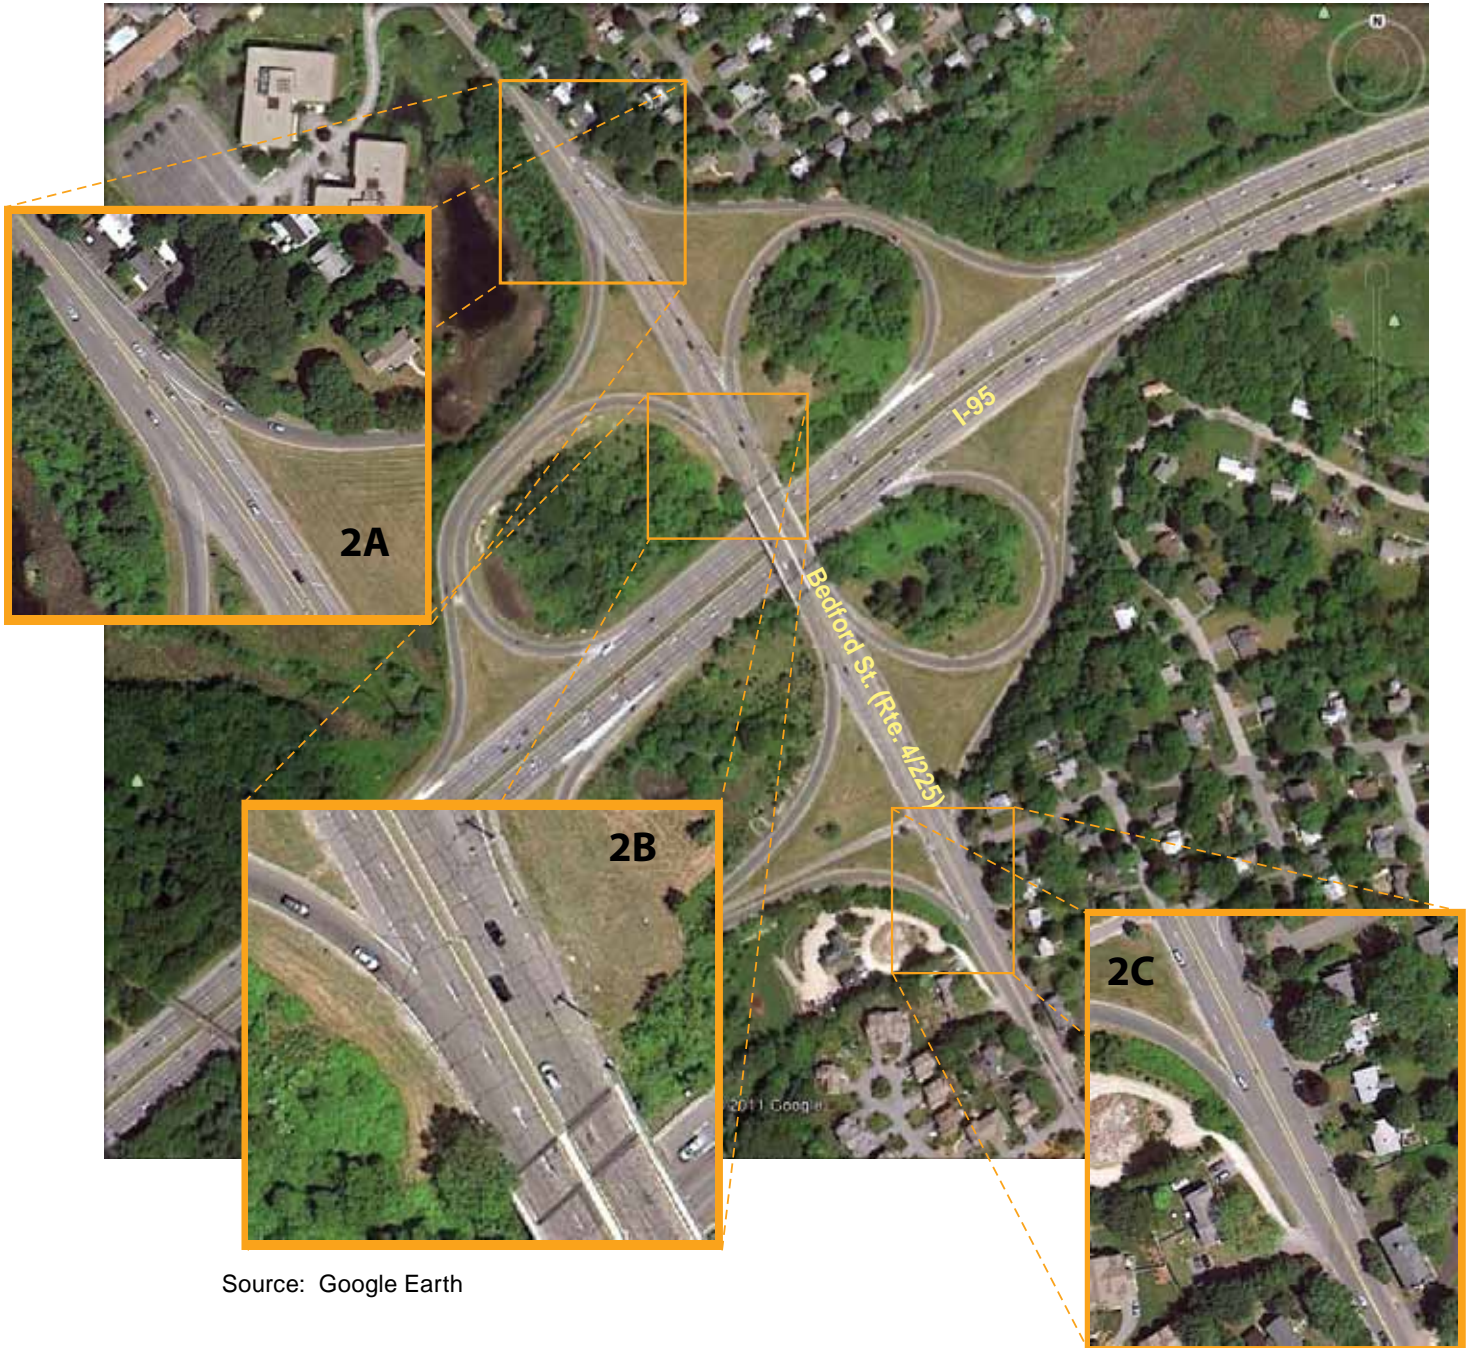
Figure 2. Intersection 1: Bedford Street/I-95, Exit 31 Ramps

RSA team members commented that while the lane use change has generally been successful at improving merging conditions at the off-ramp, police and Town officials have observed issues with the merge as it forces drivers to stay to the left and then weave across traffic exiting the ramp to then turn right to access Eldred Street, located just 500 feet west downstream. This is a heavily used movement since a local school is accessed via Eldred Street. Buses also have difficulty merging into the right-hand southbound lane to stop for the bus stop located just north of Eldred Street. These observations are based on visual observations by public safety beyond the general complaints received by the public.

Lastly, the RSA team noted that the median separating Bedford Street eastbound and westbound traffic ends just 40 feet west of the off-ramp making it tempting for vehicles to make a U-turn at that location. An RSA team member commented that vehicles making this maneuver may have either taken the incorrect exit or are trying to avoid congestion on I-95 southbound. Of the 19 crashes reported at this location, 4 (or 21%) involved vehicles trying to make a U-turn around the median even though No U-Turn signage (R3-4) is currently posted.

At this location, 8 rear-end type crashes were reported during the same time period involving vehicles at the I-95 southbound off-ramp merging onto Bedford Street eastbound (see **Figure 2B**). Most crashes occurred during the early-to-mid morning hours and on dry pavement and were the result of driver inattention, following too closely, or aggressive driving behavior. The RSA team members noted that the acceleration lane is not defined, and thus traffic from the off-ramp must yield to eastbound traffic. It is likely that these crashes occurred when the first car in the queue on the ramp determines that the gap in mainline traffic is insufficient to safely merge, but the second car in the queue believes the first motorist should merge. Then, while watching the oncoming mainline traffic instead of the car at the head of the queue, the second motorist rear-ends the first.

While the RSA team did not review crash data for this intersection, an audit team member noted that the single lane I-95 northbound off-ramp merges onto Bedford Street eastbound at a point where Bedford Street eastbound is transitioning from two to one lane (see **Figure 2C**). As a result, three lanes of traffic (two lanes on Bedford Street eastbound and one lane on the off-ramp) are required to merge into just one lane. The audit team member noted that the transition from two to one lanes on Bedford Street eastbound should occur upstream of the off-ramp to reduce the amount of merging in this location.

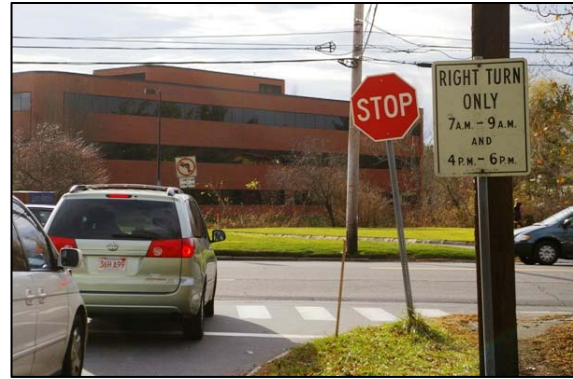
Several of these crashes (3 of 10 or 30%) occurred during the morning and evening hours when left-turns out of Eldred Street southbound are prohibited (7:00 -9:00 a.m. and 4:00-6:00 p.m.). Also reported at this location were four rear-end type crashes involving vehicles trying to make a left into Eldred Street from Bedford Street eastbound (3 of the 4 involved personal injury) and two crashes angle type crashes occurred involving vehicles making a left-turn into Eldred Street from Bedford Street eastbound with vehicles traveling along Bedford Street westbound.

Left turn prohibitions on the Eldred Street approach.

RSA team members noted that left-turn signage at this intersection is generally inconsistent, which may contribute to motorist confusion and in some cases motorists simply choosing to disobey the turn restrictions. For example, left turns out of Eldred Street southbound are prohibited only during certain hours; however, left-turns into Eldred Street from Bedford Street eastbound are not restricted. Meanwhile, left-turns both into and out of the driveway serving 420-430 Bedford Street (just across the street from Eldred Street) are prohibited; however, signage for the exit driveway is currently not provided, but is enforced by the Lexington Police Department.

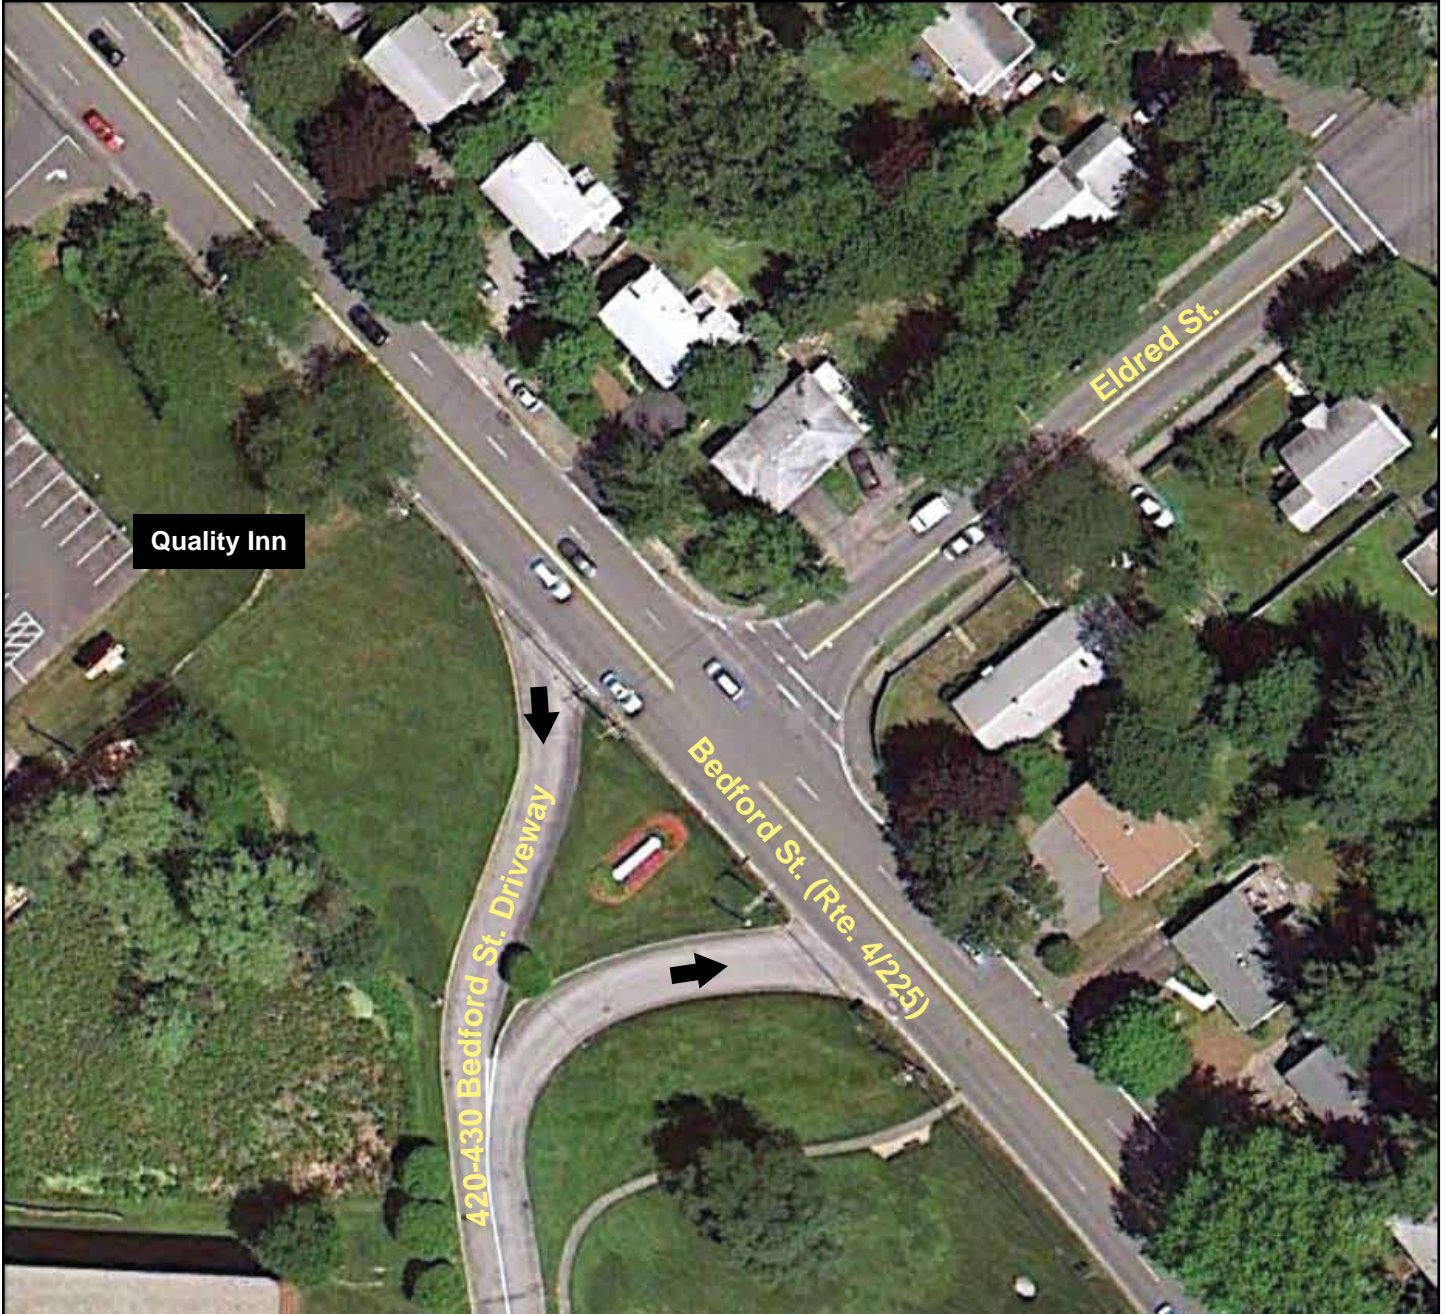
Figure 3. Intersection 2: Bedford Street/Eldred Street

From September 2008 to September 2011, a total of 33 crashes were reported at this intersection. Of these, 10 (or 30%) were angle type crashes involving vehicles on Eldred Street southbound and Bedford Street westbound. The intersection of Bedford Street/Eldred Street is shown in **Figure 3**.

Team members noted that making left-turns at this intersection is generally difficult as motorists have to judge an adequate gap across multiple lanes of traffic. Team members also noted that the presence of a fence at the northwest and northeast corners of the intersection reduce sight lines for the Eldred Street southbound approach. This combined with high travel speeds along Bedford Street may have contributed to the crash history at this location.

One member of the RSA team commented that the Town is currently evaluating the feasibility of preventing all left turns along Bedford Street through the implementation of a raised concrete median. The team noted that if a median were to be installed that it should consider the needs of pedestrians and emergency vehicles.

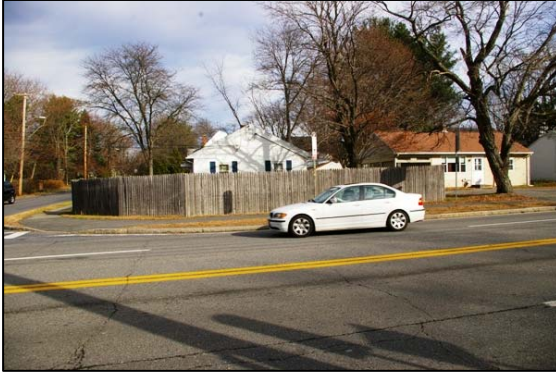
MBTA bus stop located on Bedford Street just to the east of Eldred Street.

Finally, MBTA bus stops are located just east of Eldred Street along both sides of Bedford Street; however, no crosswalks are provided across Bedford Street to allow passengers to safely access them. As a result, passengers choosing to walk to/from the residential neighborhood on the north side of roadway or one of the several businesses along the south side of the roadway must cross four lanes of traffic unprotected. In addition, no street lighting is currently provided at this location. RSA team members noted that these stops have fairly significant ridership during the afternoon commuter periods, particularly associated with workers in the adjacent hotel, restaurants, and office buildings primarily located along the south side of the roadway.

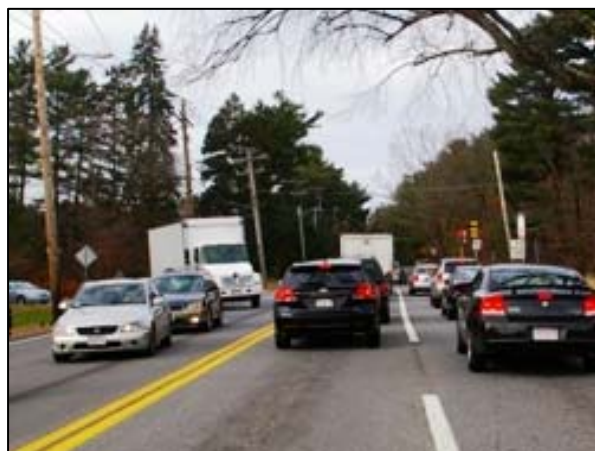
During the field observations it was noted that all signal indications at the intersection are post-mounted. Thus, large trucks exiting Hartwell Avenue northbound or waiting in the Bedford Street westbound queue can block westbound motorists’ view of the signal indications. An RSA team member also noted that the signal indication for Hartwell Avenue southbound traffic, located on the northwest corner of the intersection, is twisted towards Bedford Street making it partially visible to the Bedford Street westbound approach. It is notable that four of the five angle crashes involving Bedford Street westbound and Hartwell Avenue southbound traffic were the result motorist disregard of the traffic signal; these crashes may have been the result of motorists traveling along Bedford Street westbound believing that they had a green light due to the twisted signal indication.

A truck exiting Hartwell Avenue and blocking the westbound signal heads on Bedford Street.

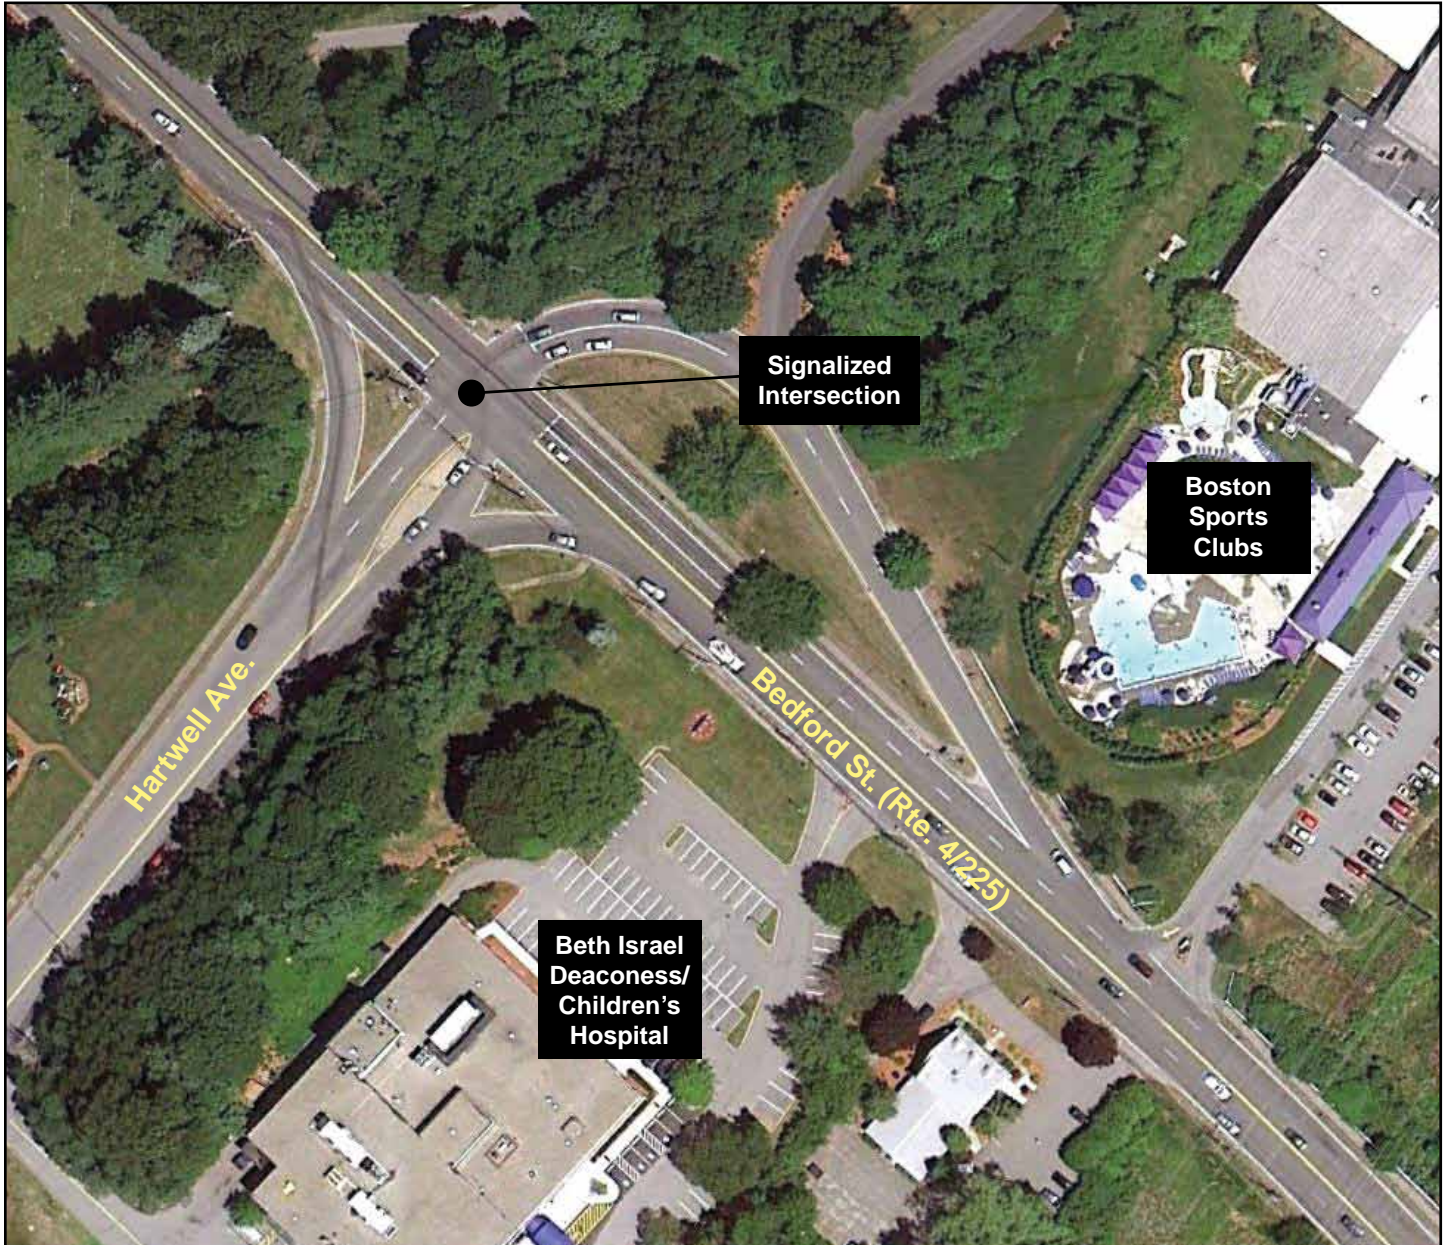
Figure 4. Intersection 3: Bedford Street/Hartwell Avenue

The intersection of Bedford Street/Hartwell Avenue is the busiest in the study area in terms of traffic volume with between approximately 3,700 and 4,400 vehicles per hour (vph) entering the intersection during the peak periods. Much of the volume at this location is attributed to the various high intensity uses located along Hartwell Avenue including several office parks, MIT Lincoln Laboratories, Hanscom AFB, and the Lexington Recycling and Composting Facility. In the past three-year period, there have been 35 crashes reported at this location for which RSA team members noted that “aggressive driving, speeds, and volume” all play a role in the crash history at this location. Of the 35 crashes, 12 (or 34%) involved either red light violations; disregard of traffic signs, signals, or road markings; and/or other aggressive driving behavior. The Lexington Police Department representative noted that he and his officers write a fair number of traffic violations at this location. Some RSA members commented that the intersection should be either redesigned as a fly-over or given aesthetic treatments to warn drivers to slow down. The intersection is illustrated in **Figure 4**.

The audit team also noted that backplates are not provided for the east–west traffic signal indications at the intersection. As such, glare from the sun at dawn and dusk may contribute to the occurrence of red light running at this location.

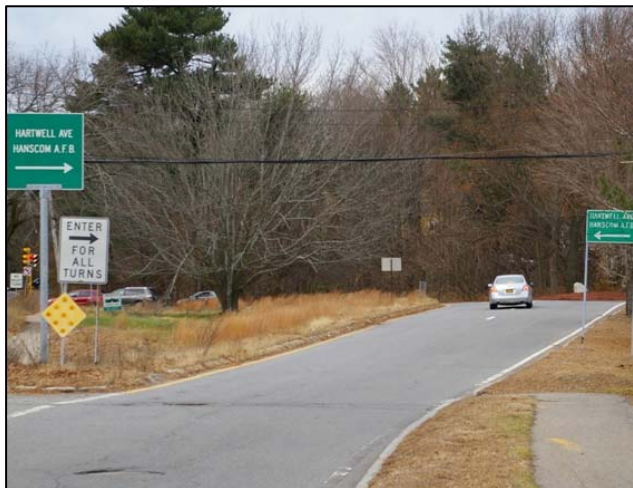
Conflicting wayfinding signage at jug handle entrance.

There are significant numbers of regulatory and guide signs at this intersection, some of them badly worn and/or confusing, and they generally contribute to the overall sign clutter along the corridor. For example, guide signage at the jug handle for Hartwell Avenue is conflicting and directs motorists with both a right arrow and then a left arrow. In some cases, motorists seeking to access Hartwell Avenue, that see the right arrow sign first, end up turning right out of the jug-handle, prior to crossing Bedford Street, and into Drummer Boy Way, the access way for the private residential area.

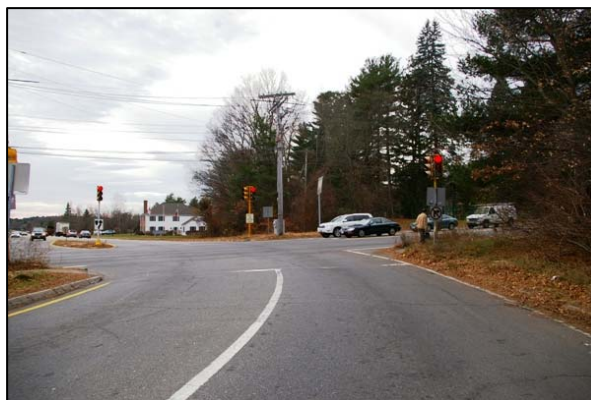
Within the two-lane jug handle, the team noted that there is a complete absence of lane use pavement markings and signage, making it unclear which lane should be used to either access Hartwell Avenue or make a U-turn to reverse direction back onto Bedford Street eastbound. RSA team members noted that drivers in the right-hand (outside) lane will attempt to make a U-turn onto Bedford Street eastbound while drivers in the left-hand (inside) lane are attempting a southbound through movement onto Hartwell Avenue resulting in either a crash or a near-miss. Of the 35 crashes, two involved vehicles trying to make a U-turn from the right hand lane.

No lane designation signage or markings at the jug-handle southbound approach.

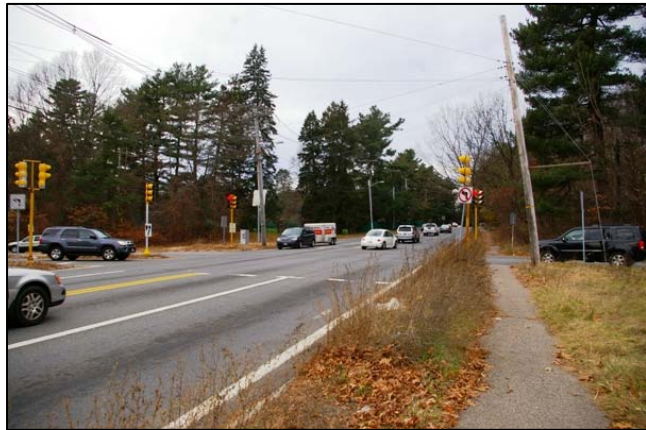
Pedestrian accommodations at the intersection are limited and provide poor connections to MBTA bus stops, which are located on both sides of Bedford Street, just east of Hartwell Avenue. There are no sidewalks on the south side of the roadway to provide connection to the bus. Meanwhile, a sidewalk is provided along the north side of the roadway; however, the bus stop is located in the center of the jug handle forcing passengers to cross either the entrance or exit to the jug handle unprotected, as no crosswalks are provided.

Sidewalk on the Bedford Street approach.

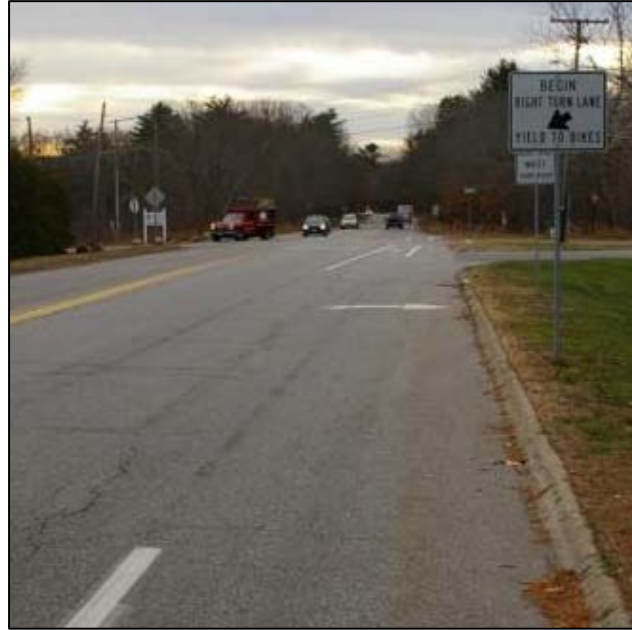
Approximately 3 to 4 years ago, the Town restriped Hartwell Avenue to reduce the number of travel lanes from two to one in each direction in an effort to formalize turning lanes, incorporate bicycle lanes, and reduce travel speeds (see **Figure 5**). While in the field, the audit team noted that the pavement markings along Hartwell Avenue southbound are generally confusing and appear to be non-standard per the Manual on Uniform Traffic Control Devices (MUTCD). North of Maguire Road, Hartwell Avenue southbound consists of one through lane and a bicycle lane. Approximately 250 feet north of Maguire Road, the bicycle lane ends abruptly and a right turn arrow has been painted on the right-hand side of what appears to be one wide travel lane, making it unclear how the bicycle lane transitions through this area and whether there is one or two southbound travel lanes for vehicles.

Confusing lane markings along Hartwell Avenue southbound.

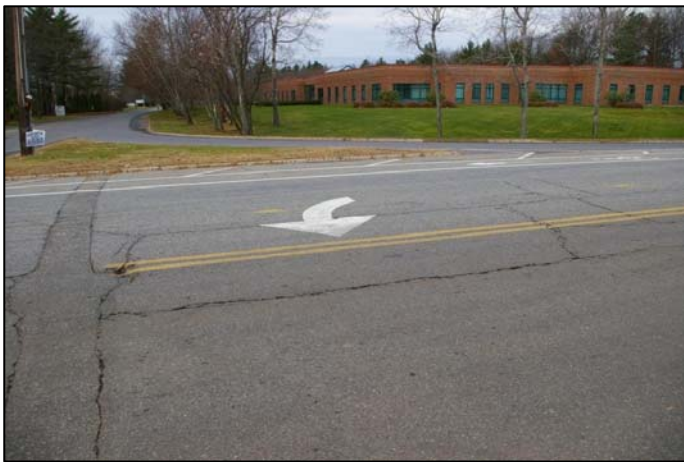
Meanwhile, on the Hartwell Avenue southbound approach to the intersection, a left-turn arrow was added suggesting a dedicated left-turn lane, a through lane, and bicycle lane; however, there is inadequate width for the two travel lanes and the pavement markings appear to be non-standard. An RSA team member indicated that the left-turn arrow may have been added in error in an effort to address left-turns into the compost facility at peak demand times; however, the need for a dedicated

Incorrectly marked left turn lane.

left-turn lane is unclear and . The team noted that the need for a dedicated southbound left-turn lane should be evaluated and that the southbound approach should then be restriped to conform to MUTCD standards. Team members commented that either the bicycle lane may be shifted to the west to allow adequate room for dedicated left-turn and through lanes or the southbound lane should be restriped as shared left-turn/through lane if a left-turn lane is not warranted.

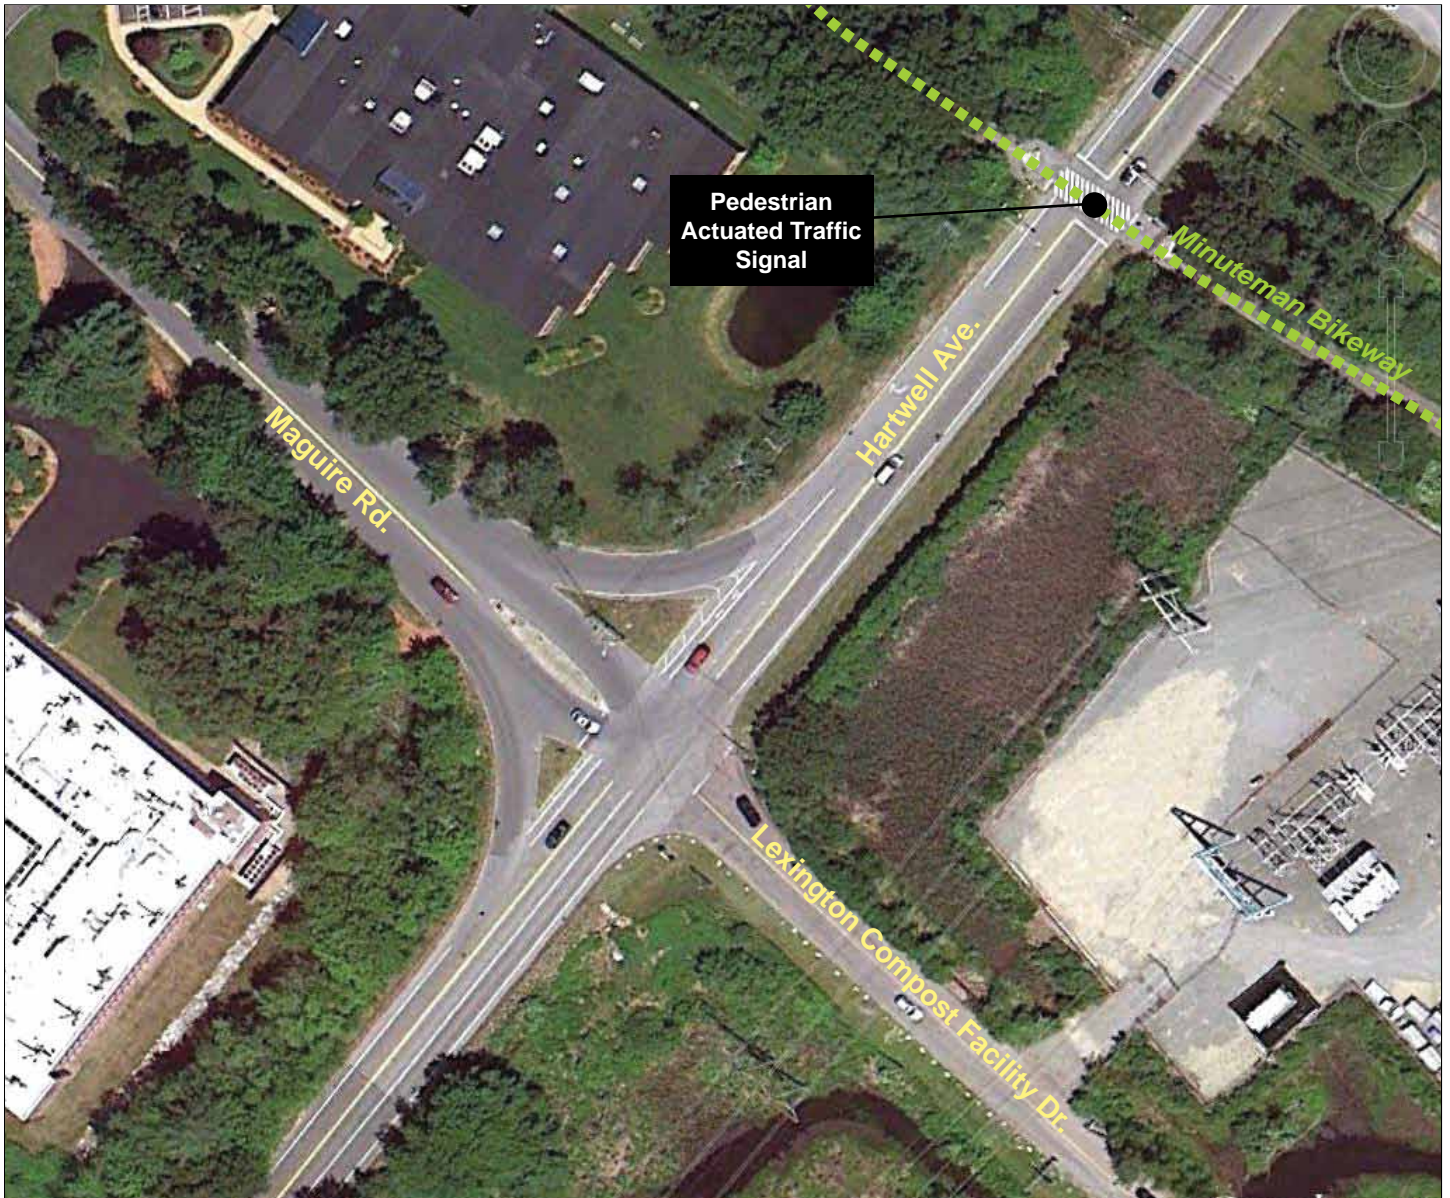
**Figure 5. Intersection 4: Hartwell Avenue/Maguire Road/
Compost Facility Driveway**

Similarly, lane use along Hartwell Avenue northbound is not well marked and occasionally leads to vehicles choosing the incorrect lane. The Hartwell Avenue northbound approach consists of a long dedicated left-turn lane (approximately 950 feet in length), a shared through/right-turn lane, and a bicycle lane. Team members noted that motorists occasionally try to make a through movement from the left-turn lane at the intersection.

Of the 15 crashes at this location, four were rear-end type involving vehicles either making a right-turn out of Maguire Road or traveling along Hartwell Avenue southbound. These crashes may have been the result of congestion along the roadway caused during either Hanscom AFB security checks or during peak demand periods at one of the nearby office parks.

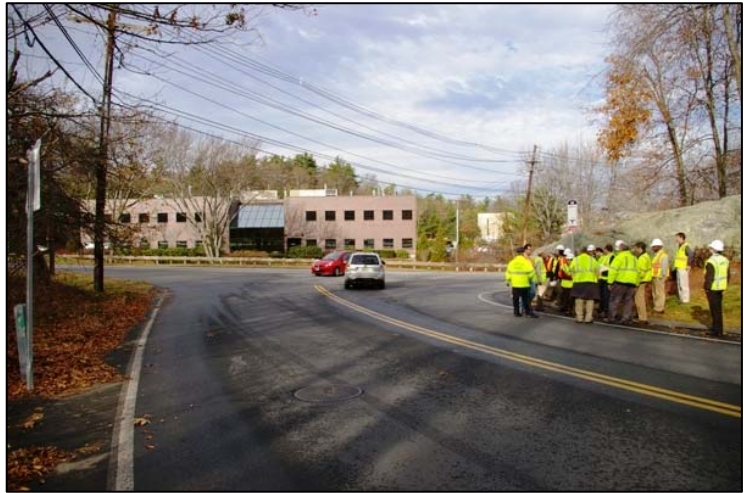
An RSA team member noted that the Wood Street westbound approach was stop controlled in years past; however, the sign (R1-1) and stop line are no longer in place. One angle type crash was reported at this intersection involving a left-turning vehicle from Wood Street westbound that failed to yield the right of way to a second vehicle traveling along Hartwell Avenue northbound. It is unknown if the stop sign was in place at the time of this crash.

The Wood Street approach without stop sign and bus stops

The team noted that the presence of a large boulder at the northeast corner of the intersection would likely limit the visibility of a stop sign if it were in place at the proposed location at the intersection approach. Team members suggested that warning signage, such as Stop Ahead (W3-1) could be put in place in advance of the stop sign to alert motorists on the Wood Street approach.

30. Wood Street southbound missing stop sign (R1-1) and stop line; however, this location is currently not a town-approved stop controlled intersection. Further consideration would be needed to determine the appropriateness of providing stop signage and pavement markings and any advance warning signage (e.g., Stop Ahead W3-1).

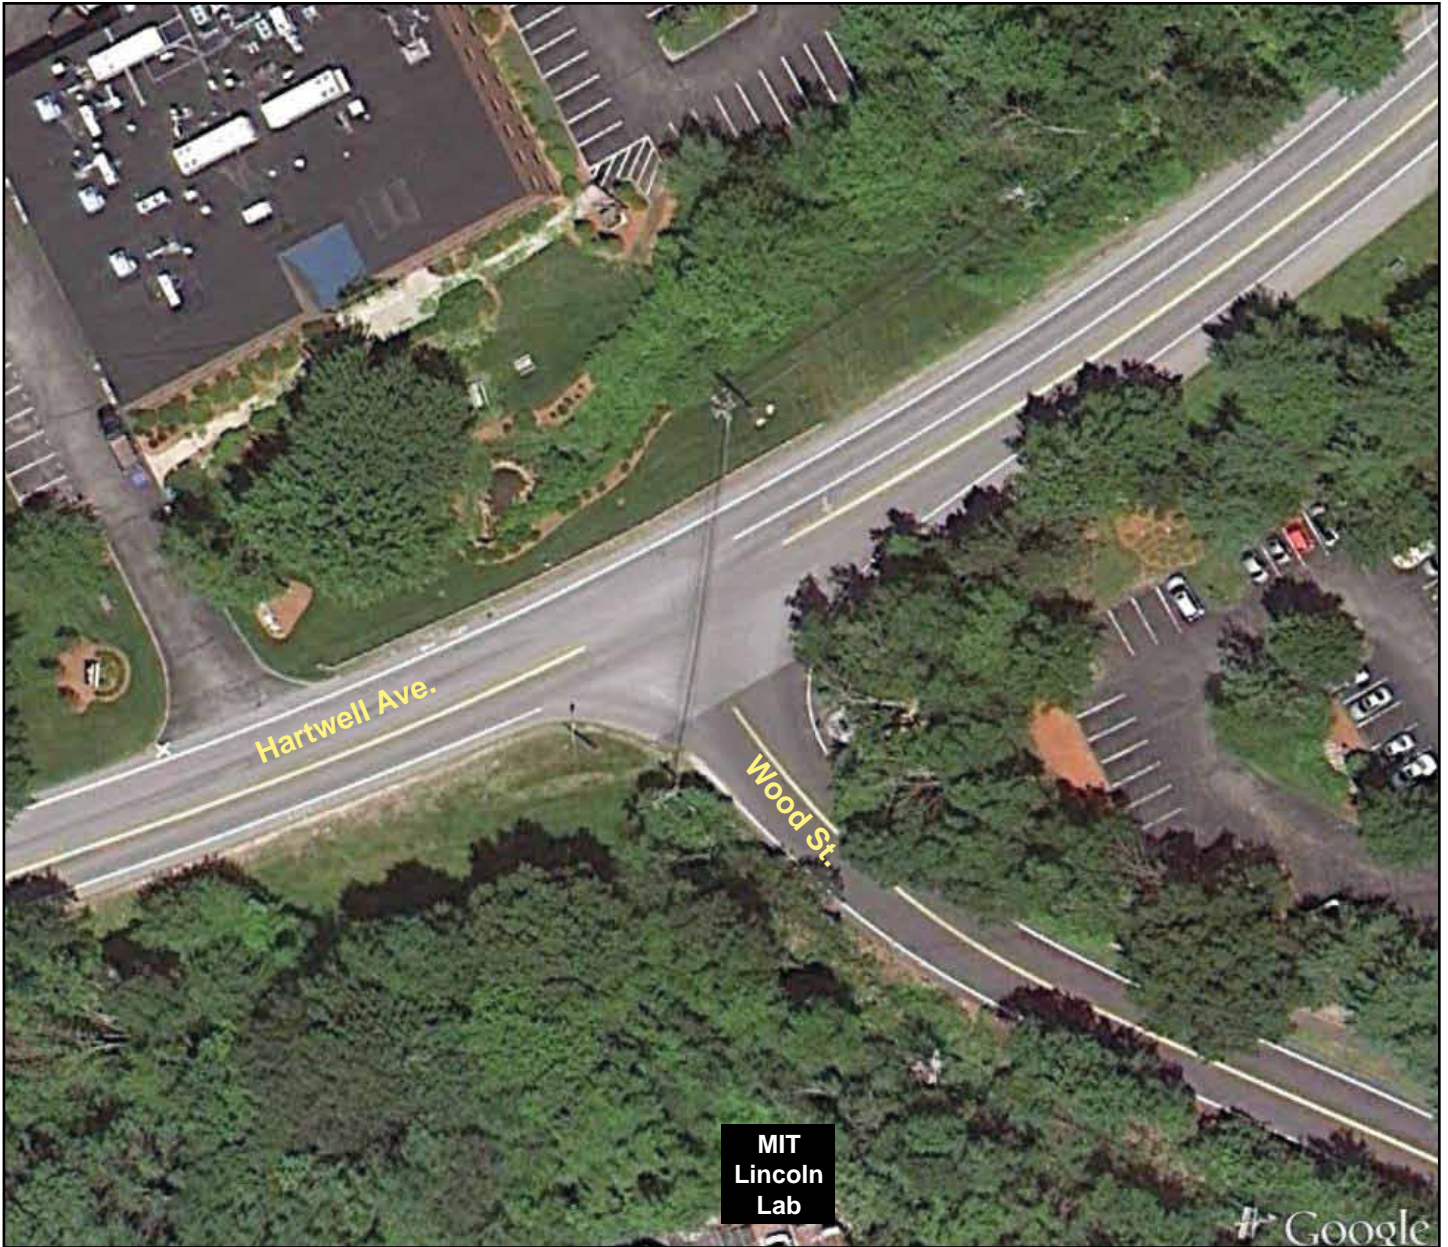
Figure 6. Intersection 5: Hartwell Avenue/Wood Street

Over the past three years there have been seven crashes reported at this intersection, including four rear-end, two angle, and one single vehicle crash involving a brake failure. The team made the following observations related to regulatory signage and markings, bus stop locations, street signage, and pedestrian conditions. The intersection is illustrated in **Figure 6**.

Sidewalks are not provided at the intersection with the exception of a short segment of sidewalk on the northeast corner of the intersection. Crosswalks are also not provided at the intersection. While pedestrian activity in the area is limited, the team noted pedestrian desire lines worn in the grass near the intersection, suggest some pedestrian demand exists – much of it likely associated with the bus stops.

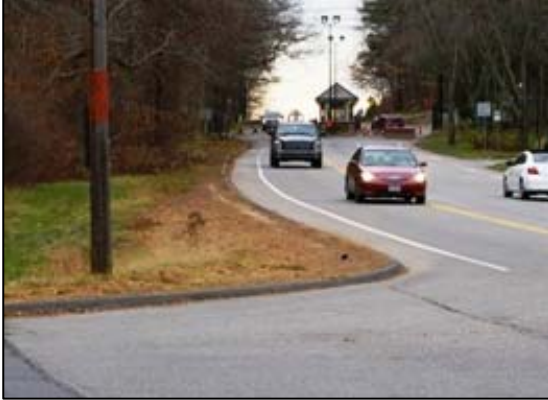
Pedestrian desire lines on Hartwell Avenue west of Wood Street.
