***ROAD SAFETY AUDIT***  
***MAJOR HIGHWAY MEDIAN***  
***CROSS-OVER CRASHES***  
**Route 2 Lexington**

**ROAD SAFETY AUDIT**

**MAJOR HIGHWAY MEDIAN  
CROSS-OVER CRASHES**

**FINAL REPORT**

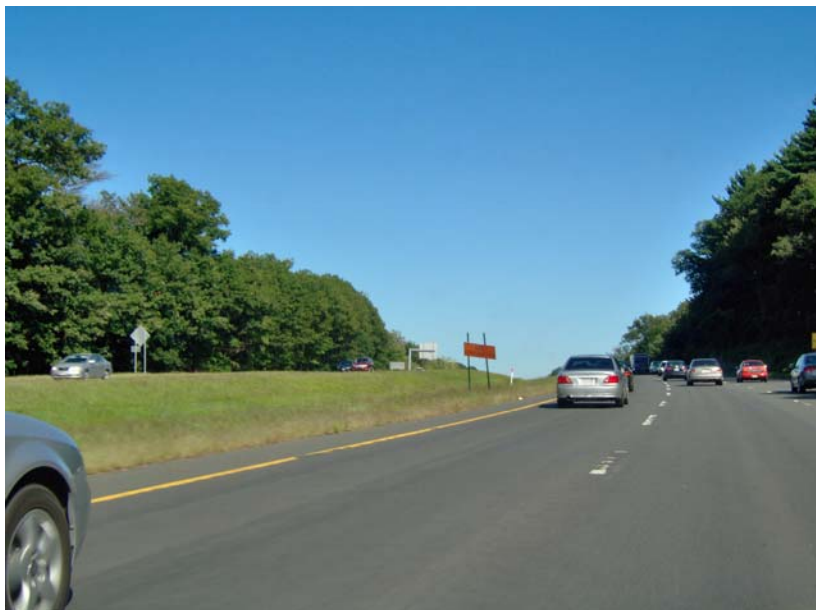
The section of highway in the study area for the most part, has an inside shoulder that appears less than 3 feet in width and no rumble strip or recessed reflectors in place at the time of this analysis. There was a noticeable edge drop-off on a number of locations along the study section as well. In addition, this section of Route 2 does not have the reflective delineator posts installed alongside the median. The low level of guidance was cited as a potential contributing factor to median related entries particularly during times of low visibility.

**Figure 3 – Eastbound on Route 2 – some areas in study section have elevation difference between the two directions of flow**

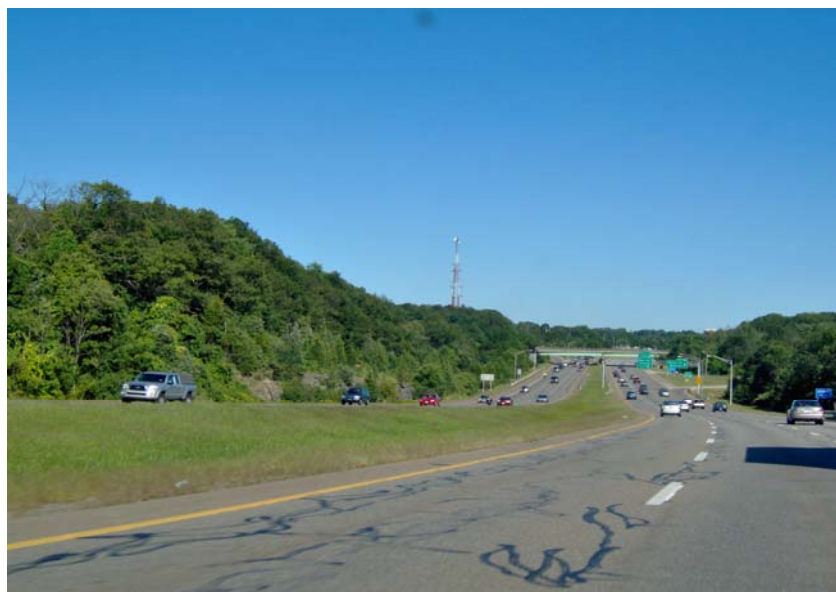
The width of the median (measured from presumed edge line to edge line) in the project area was primarily between 65 and 70 feet. In total, 2.3 miles of the 3.8 mile section of the median is considered “open” with no barrier present. The Route 2 median is generally clear of trees and other small vegetation.

**Figure 4 – Median is generally open without vegetation other than grass**

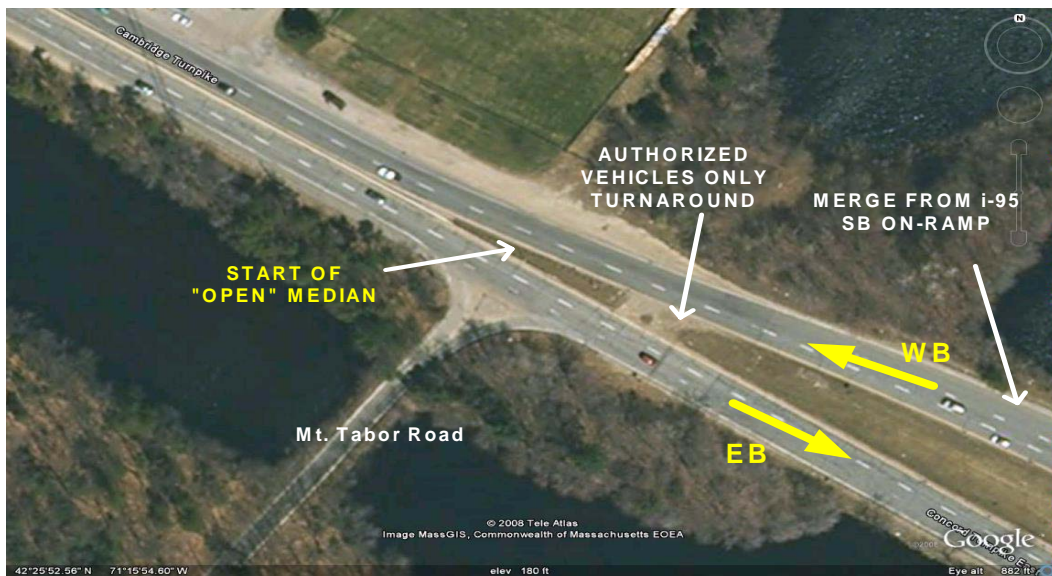
Figure 8 - Area Near Mt. Tabor Road

On the west side of the I-95 interchange, the median narrows east to west in the vicinity of Mt. Tabor Road where a concrete barrier that separates directional exists just west of Mt. Tabor Road. It is a location where a non-fatal cross median crash was reported. There is no barrier in the median east of the concrete barrier. The area is also where an "Authorized Vehicle Only turnaround" is located as shown in Figure 8. A rating of 'B' was assigned in relation to the turnaround as it is close to the I-95 southbound off-ramp to Route 2 westbound and in an area where westbound merging occurs.

The area near Mt. Tabor road needs attention as the median narrows in this area and the “Authorized Vehicles Only turnaround” exists just east of Mt. Tabor Road. With regard to the turnaround, it is recommended that it be shifted more to the east away from Mt. Tabor Road to establish greater separation and clearly identified in terms of its restricted use.

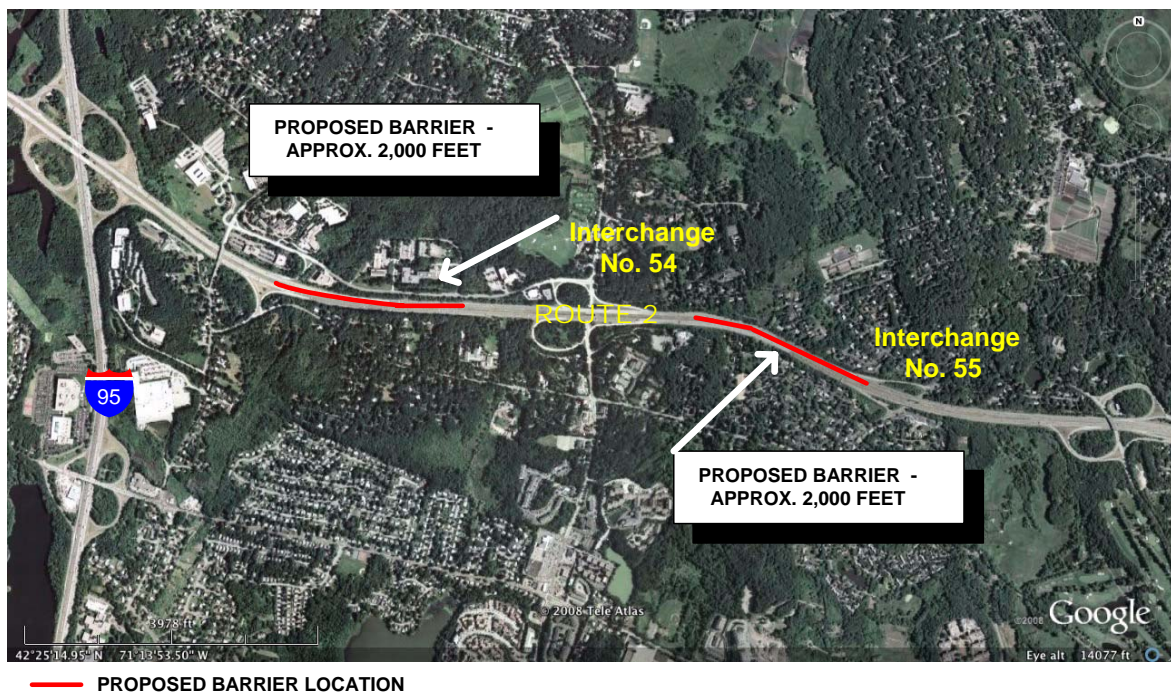
Figure 10 - Proposed Barrier Locations

In addressing the open median issues, the RSA team further examined the study section to identify the particular areas where it was felt a barrier would be a positive and effective action. The area near Mt. Tabor Road where the wide median section was transitioning to the “no-barrier” section of Route 2 into Lincoln and Concord was one location. The drive-thrus pointed to several areas where the combination of the horizontal alignment together with the elevation difference of the highway directions gave a sense that entering the median and potentially crossing it were more possible. These approximate locations are shown in Figure 10.
