# ROAD SAFETY AUDIT

Massachusetts Avenue at Maple Street

Town of Lexington

May 17, 2012

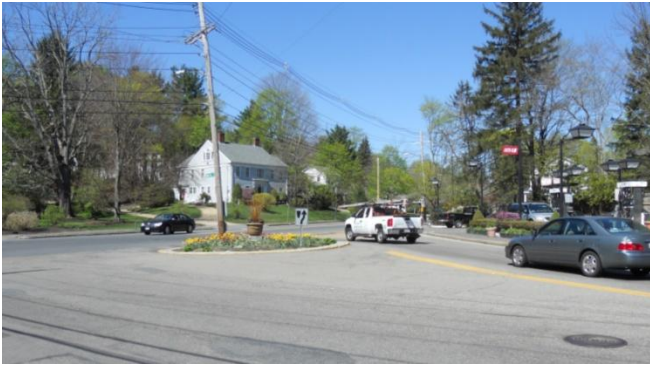
- Lack of Traffic Control – No traffic control devices are provided at the intersection. The left turn from Maple Street generally operates as a STOP-controlled approach, although neither a STOP sign or a painted STOP bar are provided. The right turn from Maple Street to Massachusetts Avenue westbound generally operates as a yield, but the lack of yield sign or yield markings may give vehicles on Maple Street the false sense that they have the right of way. A number of crashes at the intersection may be attributed to the lack of traffic control, especially the four crashes related to the right turn lane from Maple Street.

- Install STOP and Yield signs for the Maple Street approach. The left turn from Maple Street to Massachusetts Avenue generally operates under STOP control, and should have a STOP sign installed. A Yield sign should be installed for the right turn lane from Maple Street to Massachusetts Avenue westbound. This is a low cost improvement that should be implemented immediately in advance of long-term improvements at the intersection.

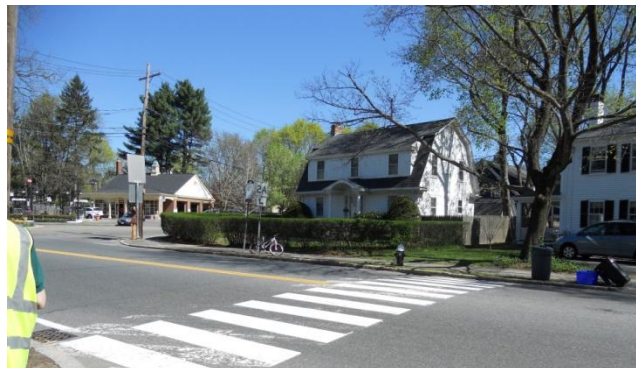
- The excessive width of Maple Street provides a challenge for pedestrians and bicyclists, who must cross both a wide departure lane with vehicles turning from a wide range of entry points and at a great variance in speeds, and a wide approach area with two separate turning lanes and a wide, unprotected painted gore area. This may be a factor in the two bicycle crashes that occurred at the intersection.

- Reduce width of the Maple Street approach. The excessive width creates a number of potential safety issues documented in this report. A significant reduction in width can be achieved while still maintaining adequate turning radii and lane widths to allow all existing turning movements. A beneficial side effect is the creation of additional green space at the intersection. This is a long-term, high cost improvement that can be incorporated into other improvements proposed at the intersection.

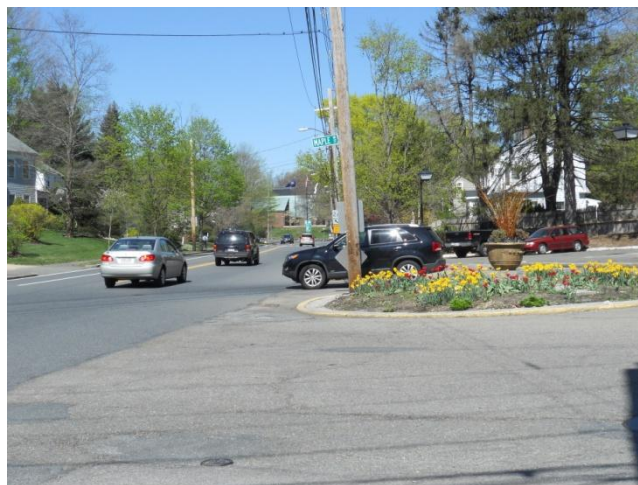
- The marked left turn lane from Massachusetts Avenue eastbound to Maple Street is approximately 150 feet in length, but ends at a point adjacent to the southern edge of the painted gore on the Maple Street approach in order to avoid conflicts between vehicles turning left from Massachusetts Avenue and vehicles turning left from Maple Street. A vehicle turning left from Massachusetts Avenue must travel approximately two to three car lengths beyond the end of the turn lane before making the turn onto Maple Street, and vehicle queues often start at the point where vehicles turn from, not the point where the turn lane ends. As a result, left turn queues from Massachusetts Avenue block left turns from Maple Street. In instances where vehicles in queue leave gaps for vehicles from Maple Street, the cars in queue present visibility constraints for turning vehicles. The blockage of turning movements and constrained visibility are likely a factor in the angle crashes involving left turning vehicles.

- Widen Massachusetts Avenue between Marrett Road and Maple Street. The short segment of Massachusetts Avenue between these two roadways includes the two lane approach section at Maple Street. This segment should be widened to provide lane and shoulder widths meeting state guidelines. This long-term, high cost improvement can be incorporated into traffic signal improvements at the intersection, but may not be required if a roundabout is constructed.

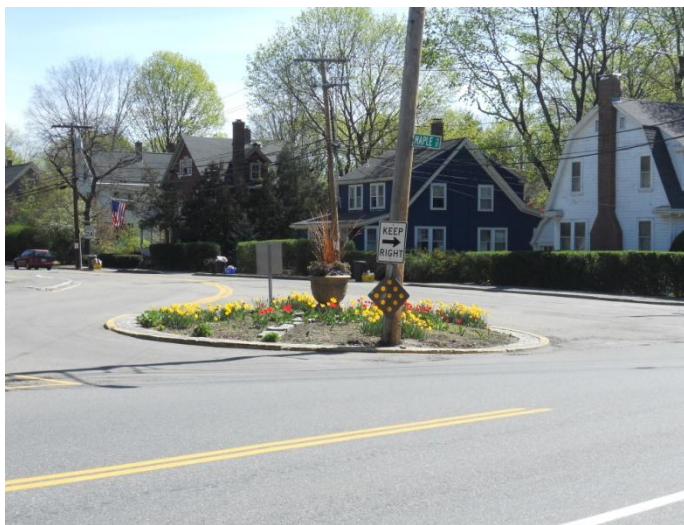
The Massachusetts amendments to the Manual on Uniform Traffic Control Devices (MUTCD) state that an H1-2 warning cluster panel should be used in place of MUTCD standard object markers, and that H1-2 panels shall be used only where traffic can pass on both sides (immediately to the right or left side) of a gore, island, or other obstruction. The H1-2 object marker on this island is visible to eastbound vehicles on Massachusetts Avenue, who can only pass to the right side of the island when turning to Maple Street.

- Remove H1-2 object marker from the circular island. This sign is not in compliance with the Massachusetts amendments to the MUTCD and should be removed. This is a short-term, low cost improvement.
