ROAD SAFETY AUDIT

Bedford Street and Hartwell Avenue

Town of Lexington

November 2011

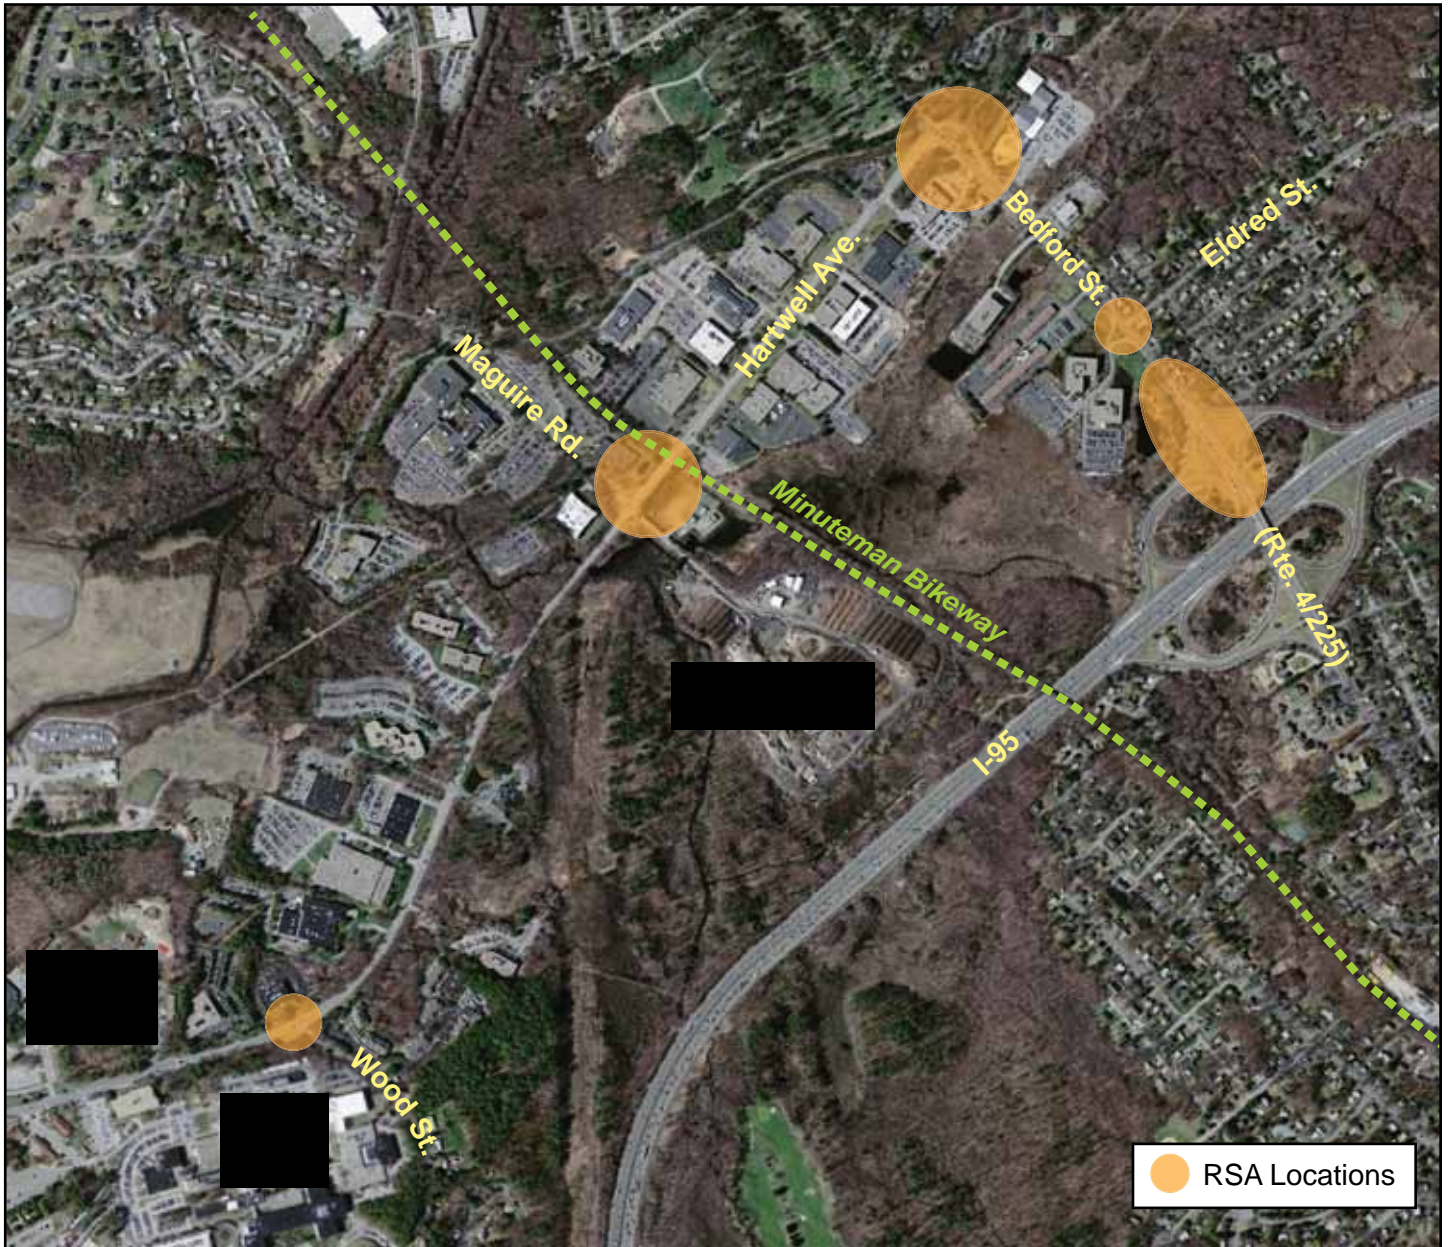
Figure 1. Locus Map

The section of Bedford Street, between I-95 and Hartwell Avenue, and Hartwell Avenue in its entirety, is located in the Town of Lexington, Massachusetts, as shown in the aerial image in **Figure 1**. Bedford Street provides access to a hotel, commercial, and office uses along its south side and a mix of residential and commercial uses along its north side. Hartwell Avenue extends south from the intersection of Hartwell Avenue/Bedford Street to an entry gate for Hanscom Air Force Base (AFB). In addition to Hanscom AFB, Hartwell Avenue provides access to several office parks and, via Wood Street, the Massachusetts Institute of Technology (MIT) Lincoln Laboratory.

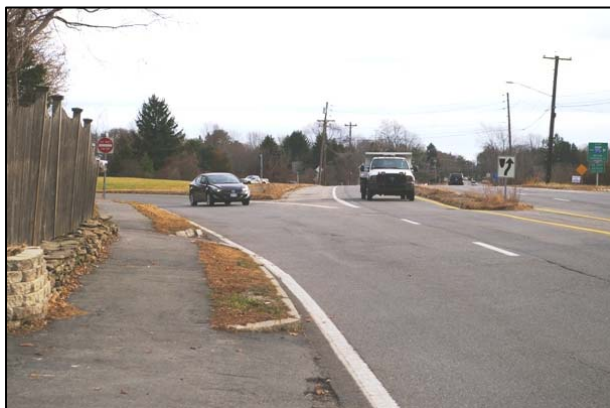
Bedford Street Westbound at I-95 Southbound Exit 31B Off-ramp:

The I-95 southbound off-ramp merging with Bedford Street westbound.

From June 2008 to September 2011, a total of 19 crashes were reported at this location (see **Figure 2A**). A majority of the crashes were rear-end type (13 or 68%) and occurred during daylight hours (13 of 13) and on dry pavement (10 of 13 or 77%). According to the RSA team, the off-ramp was recently reconfigured to flow freely onto Bedford Street without requiring a yield in an effort to reduce/eliminate the queuing onto I-95. This was accomplished by reducing the number of lanes on Bedford Street westbound from two lanes to one lane at the merge with the off-ramp.

RSA team members commented that while the lane use change has generally been successful at improving merging conditions at the off-ramp, police and Town officials have observed issues with the merge as it forces drivers to stay to the left and then weave across traffic exiting the ramp to then turn right to access Eldred Street, located just 500 feet west downstream. This is a heavily used movement since a local school is accessed via Eldred Street. Buses also have difficulty merging into the right-hand southbound lane to stop for the bus stop located just north of Eldred Street. These observations are based on visual observations by public safety beyond the general complaints received by the public.

Lastly, the RSA team noted that the median separating Bedford Street eastbound and westbound traffic ends just 40 feet west of the off-ramp making it tempting for vehicles to make a U-turn at that location. An RSA team member commented that vehicles making this maneuver may have either taken the incorrect exit or are trying to avoid congestion on I-95 southbound. Of the 19 crashes reported at this location, 4 (or 21%) involved vehicles trying to make a U-turn around the median even though No U-Turn signage (R3-4) is currently posted.
