***ROAD SAFETY AUDIT***  
***MAJOR HIGHWAY MEDIAN***  
***CROSS-OVER CRASHES***  
**Route 2 Lexington**

**ROAD SAFETY AUDIT**

**MAJOR HIGHWAY MEDIAN  
CROSS-OVER CRASHES**

**FINAL REPORT**

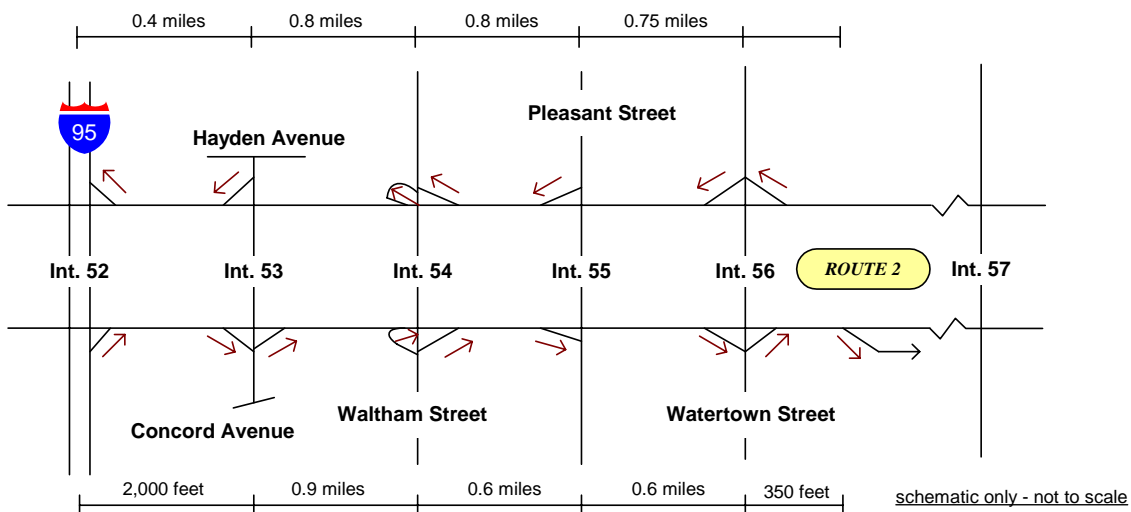
**Figure 2**  
**Spacing of Interchanges**

The spacing of the interchanges is relatively close as depicted in Figure 2. As can be seen, the five interchanges within the study area are closely spaced. From I-95 eastward, the next four interchanges are located in 2.5 miles. It is noted that not all the interchanges are fully directional interchanges, which may alleviate to an extent the close spacing.
